CANTSINK
SUPPORTING INNOVATION

Case Study

ATLANTA RANDALL MILL POOL DECK

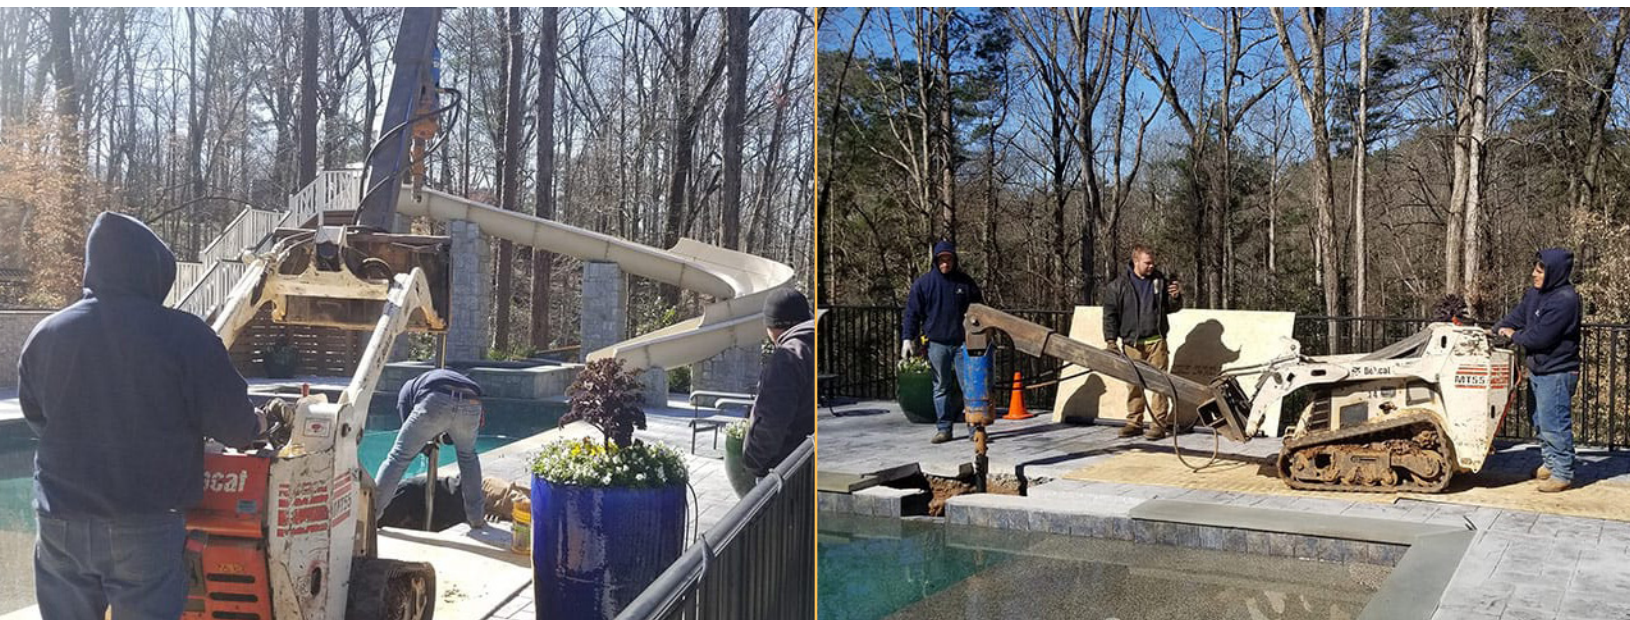
Cantsink's skill and experience preserved the surroundings while inserting four new construction piles to support the pool where it was showing signs of instability.

Four piles comprising 21 feet of support. Piles were installed to a load capacity of 1,500 PSI.
